MP 249 – 250: Berthoud Falls

Within this section is the community of Berthoud Falls, a possible camp site of Jim Bridger and Captain Berthoud and two avalanche chutes.

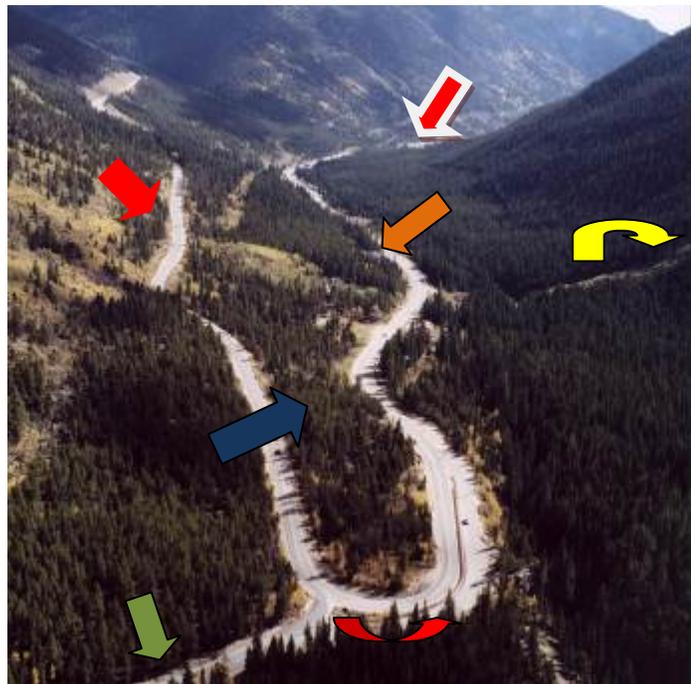
U. S. Highway 40 – red arrow

Berthoud Falls – blue arrow

CDOT Shop – orange arrow

Berthoud Falls slide – yellow

Henderson Mine and Jones Pass Road - green

The Big Bend/ Henderson Curve looking at
Berthoud Falls
Date: 2007
Photo provided by and used with permission from
Gregg Gargan: Colorado Department of Transportation Photographer

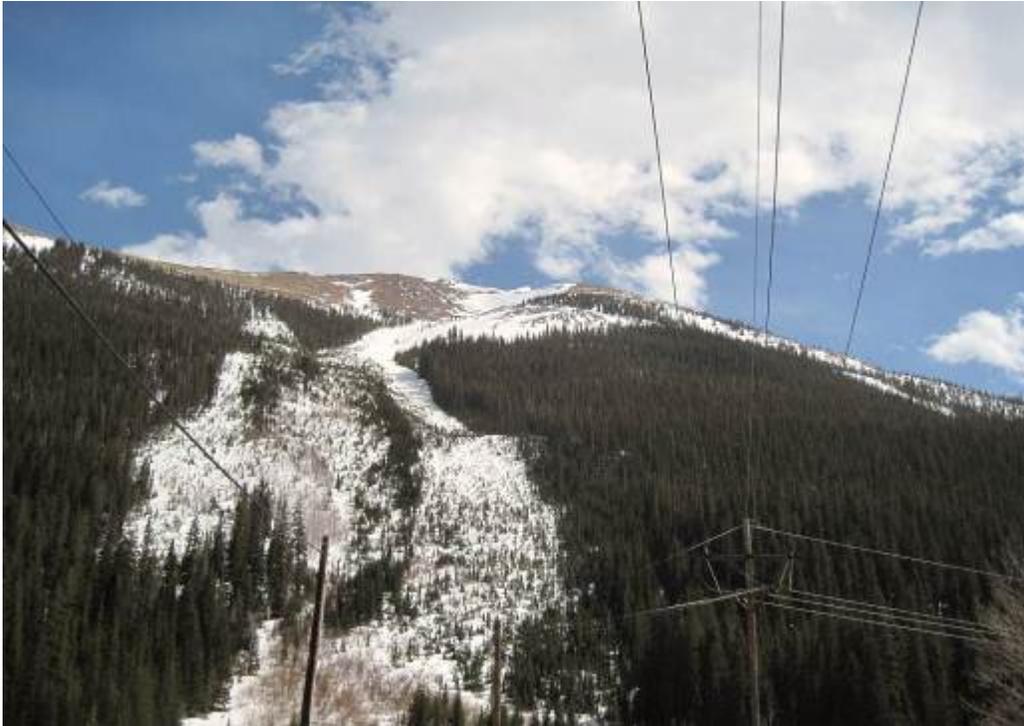
**Avalanche Path:
Stanley**

Location: Lower road crossing: 249.8 Upper road crossing 247.7

Starting Zone elevation: **12,400 ft.** Vertical fall to roadway: **2,700 ft.**

Runout Zone elevation: **9,660 ft.** Maximum vertical fall: **2,740 ft.**

Length of path: **6,145 ft.**

Length of road affected: **1,200 ft. upper roadway - 700 ft. lower roadway**

Average avalanche activity/year: **8.00**

Average avalanche activity affecting road/year: **Upper roadway: 4.20**

Lower roadway: 0.18

Mobile control: **105mm Howitzer, Helicopter bombing**

Comments: Because the entire avalanche path can be seen at the lower road crossing, the Stanley avalanche path will be discussed within the lower road crossing mile points. The Stanley avalanche path is listed as one of the most hazardous avalanche paths that cross a highway in Colorado. Factors used to arrive at this rating is the number of vehicles that cross under the path daily, the number of times an avalanche impacts the highway, the potential volume of snow that could reach the highway and the destructive potential if an avalanche strikes a vehicle.

When a large avalanche occurs within the Stanley path, the debris can reach the lower roadway and has done so at least 5 times since 1973. The earliest avalanche known to reach the roadway in a season occurred September 26, 1959 and the latest occurred June 6, 1996 when it deposited 20 ft. of snow on the upper road. An avalanche from the Stanley on February 16, 1945 claimed the life of Harold Willis when the avalanche swept the car he was driving off the upper road. Four more vehicles have been hit by avalanches from the Stanley, one in 1973, another in 1989 and the last time occurred January 6, 2007 when an avalanche swept two vehicles carrying 8 people off the road. All four of these vehicles were destroyed by the avalanche, but luckily the vehicles' occupants were not seriously injured.

The Stanley Avalanche Slide can be seen between these two mileage posts. Information about this slide is found under the avalanche information found in this section. Additional information can also be found in the section for MP 247-248.

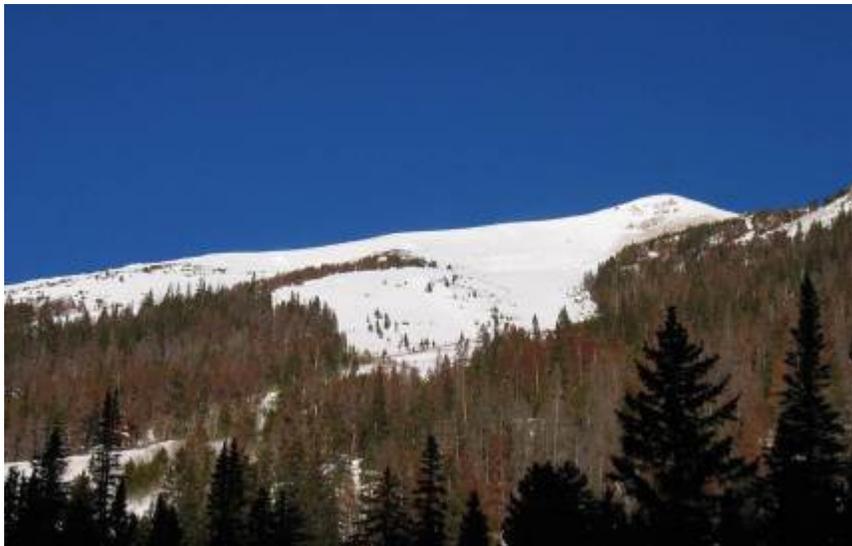
**Photo of the Stanley avalanche area taken from the lower run out area
Taken by Raymond T. Mumford - 2011**
